Fiber Polarity

by Jerry Dillard, CTO/Co-Founder

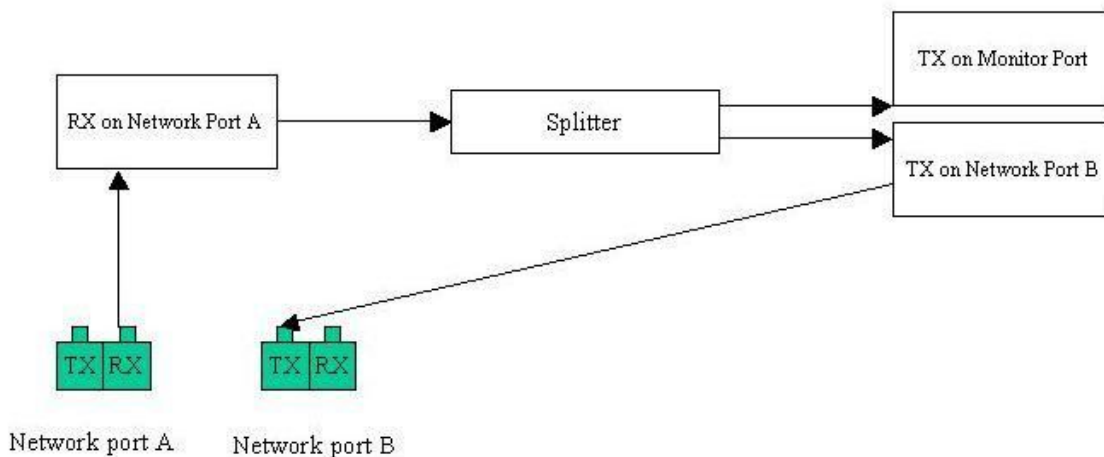
The light ingresses port A's RX port of the LC connector and enters the splitter. The light traverses the splitter and since light travels in a straight line some light will egress the two outputs on the right side of the picture and we achieve what we want – light egresses port B's TX port and some light egresses one of the monitor ports.

Likewise the light would enter the right side of network port B and would egress the TX port of port A and the monitor port – this path isn't shown but it is the same as the path from port A to port B and the monitor port. This path uses a second Splitter that isn't shown.

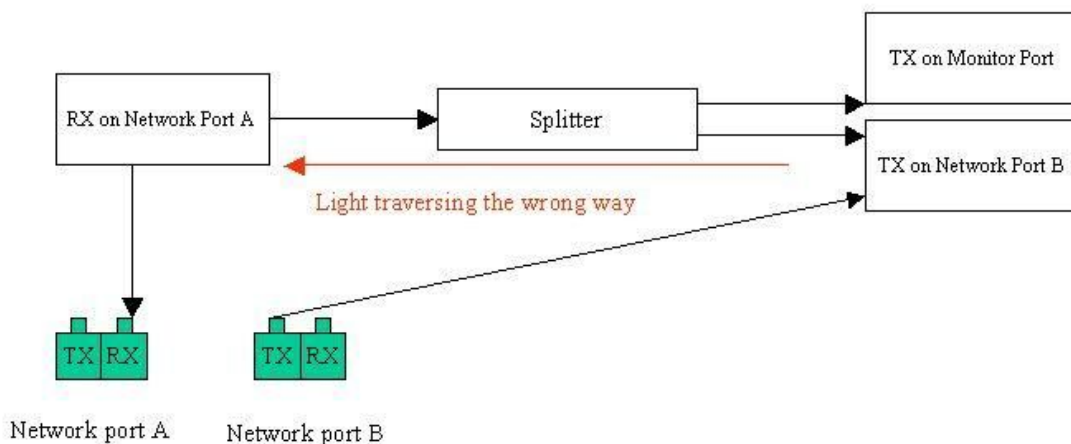
Now let's talk about what happens in some cases. For some reason, the cabling ends up such that when the fibers are plugged into the network ports of the TAP they have the wrong polarity. They send the light into the left side of the LC coupler instead of the right (again when the LC coupler is positioned with the TABS up). I am going to show what happens when we reverse the light path I show above. **Look at the following figure below:**

We still have a straight-line path from the light ingressing port B going to port A. So the light still makes its way from the device connected on port B to the device connected to port A of the TAP. Likewise the reverse path – i.e. light from the device connected to port A will have a straight-line path from port A to port B of the TAP (this path isn't shown). **So the two devices connected to the network ports link!**

But we have a problem. There is no straight-line path for the light to egress the monitor port. **Look at the above figure**, the light is now entering the side of the splitter which should be the output - but the splitter isn't designed to send that light out the top right connection shown in the figure (to the monitor port). So we get a VERY weak signal out the monitor ports or none at all. Sometimes if the monitoring tool has very sensitive SFPs it will work but we would not want to trust that since it is only marginal. A lot of the times they don't link at all.

Unplug the LC couplers on the TAPs' network ports A and B and reverse the polarity – ***but only on the end connected to the TAP.*** If you were to do this on both ends of the fibers connected to the network ports you would be right back where you started.

So, in a nutshell if the devices connected to the TAPs' network ports link but the monitoring ports do not, we have often fixed the problem with reversing the polarity on the network ports.
